Crane Inspection Guide

a general guidance for container vessel cargo crane inspections conducted on through MATE[®]

version 2019.1

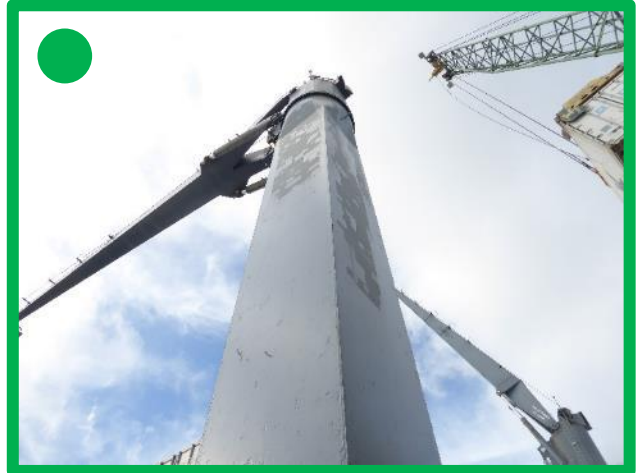
Superficial corrosion along pedestal edge

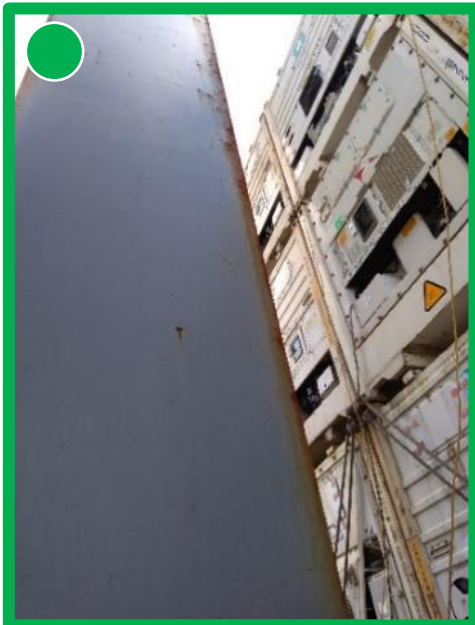
No corrosion

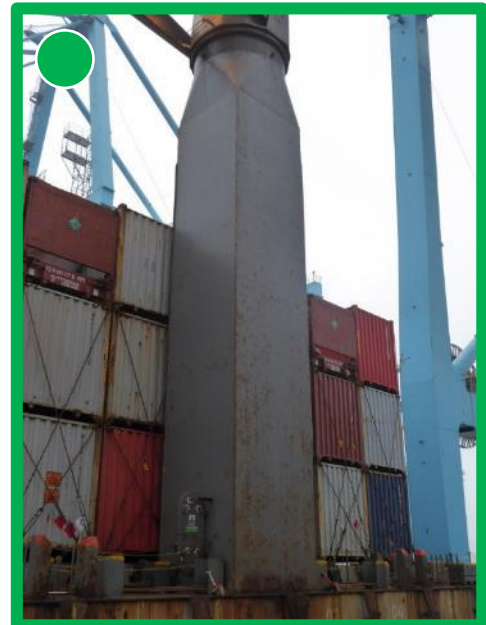
Superficial corrosion along pedestal edge

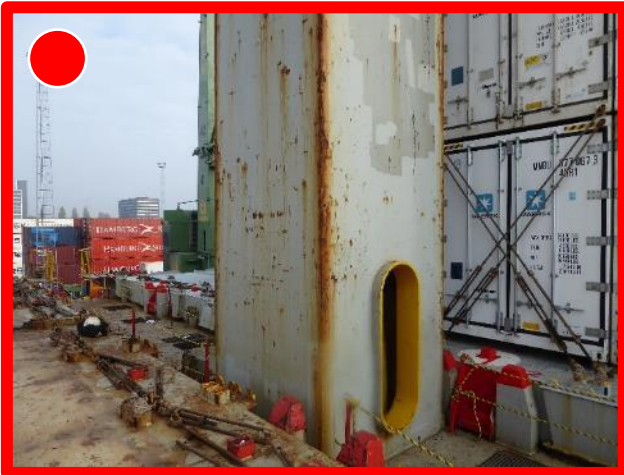
Excessive corrosion along pedestal

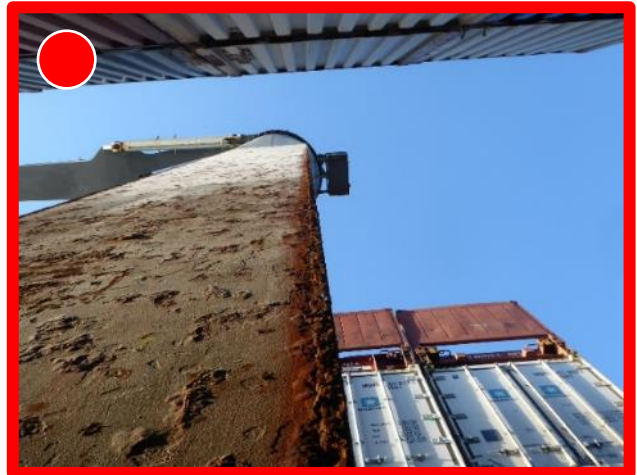
Excessive corrosion along pedestal

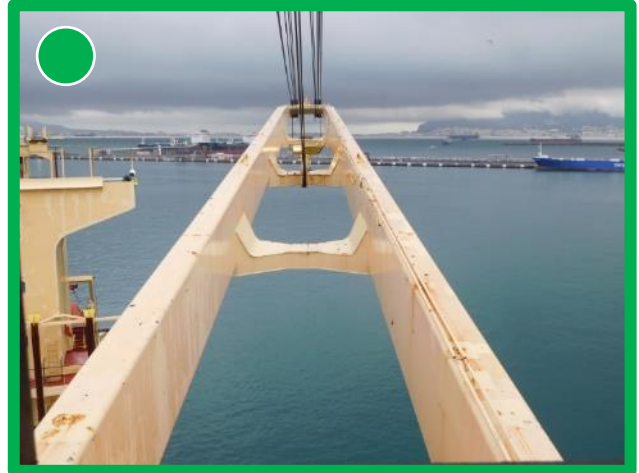
Superficial corrosion on jib

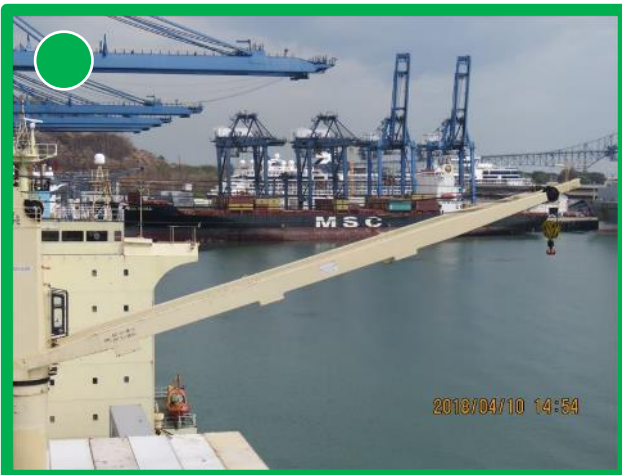
Superficial corrosion on jib

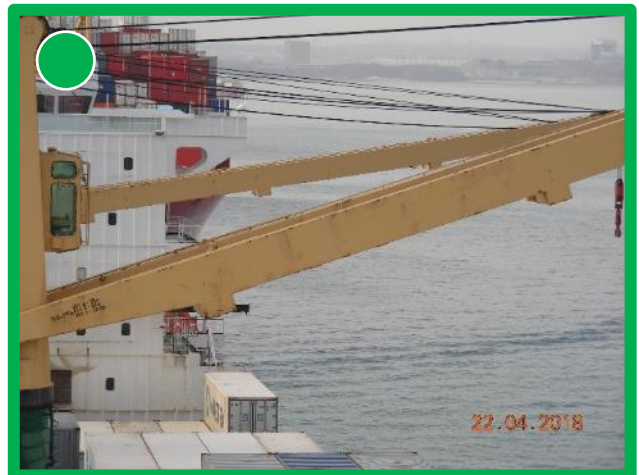
No corrosion

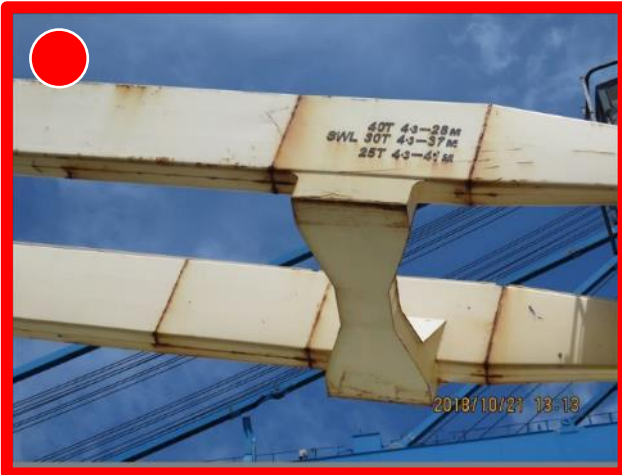
Jib with (localised) excessive corrosion

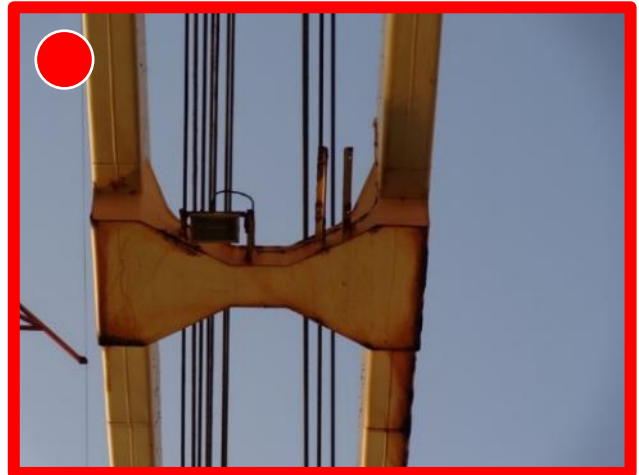
Jib cross beam with excessive corrosion

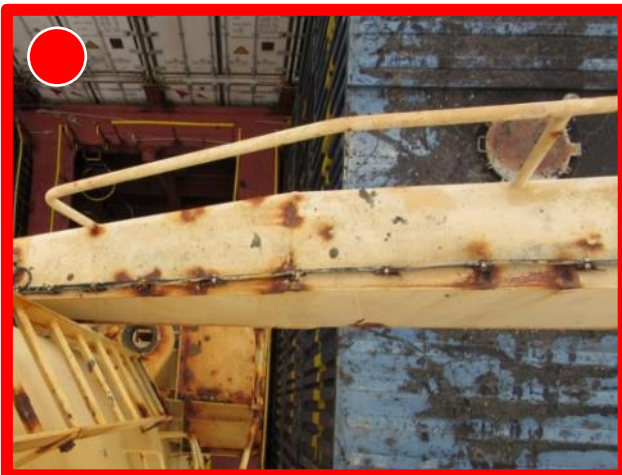
Jib with spots of excessive corrosion

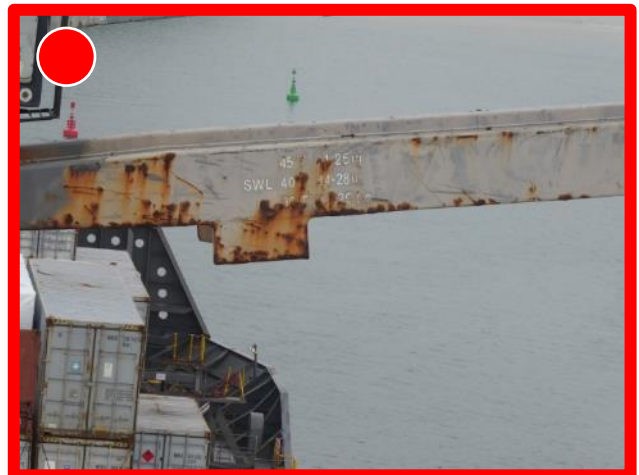
Excessive corrosion along jib

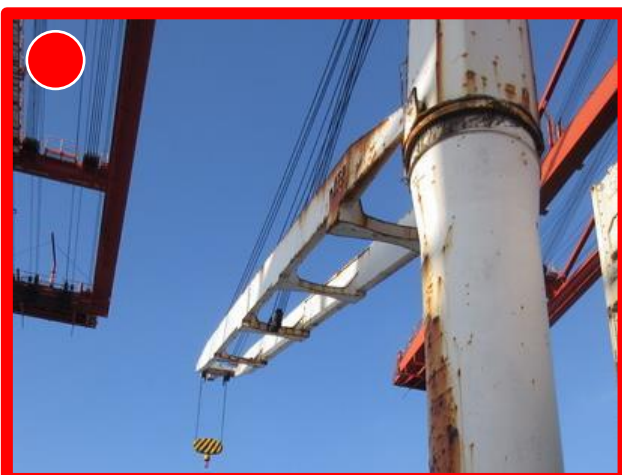
Jib with excessive corrosion (also on pedestal and slewing ring)

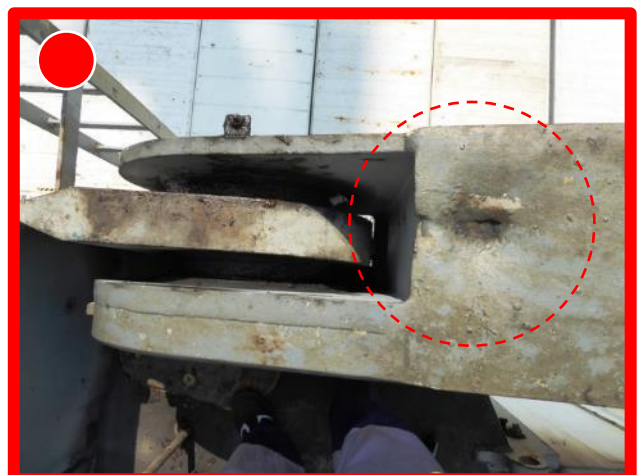
Heavy indentation on jib top plate near pivot point

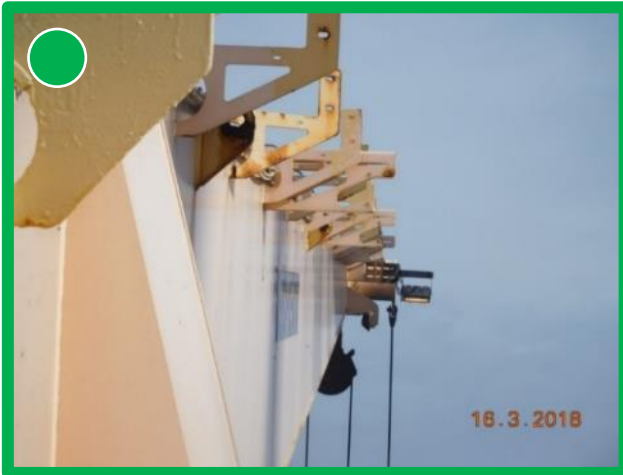
Jib grating supports with progressive corrosion

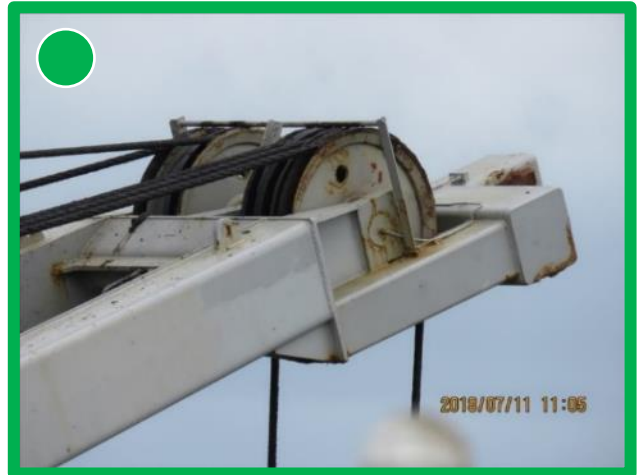
Jib end sheave with progressive corrosion

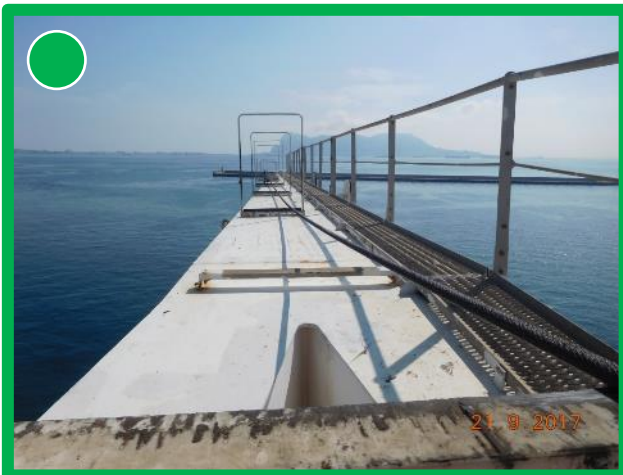
Jib, sound condition

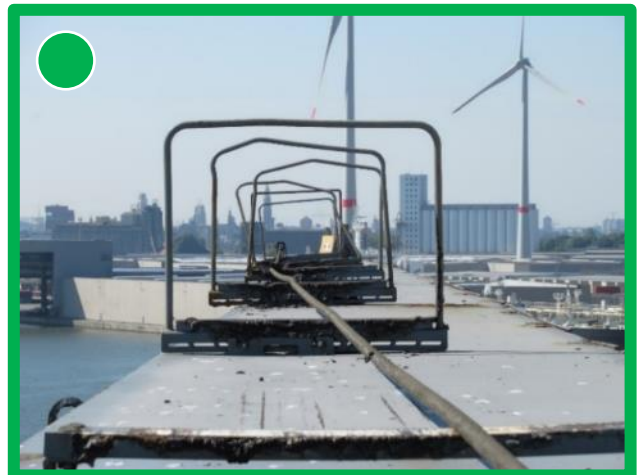
Wire jumpers bent but sound

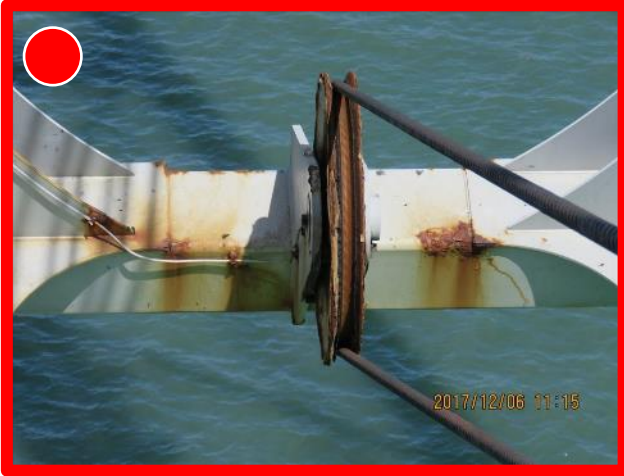
Jib with local excessive corrosion

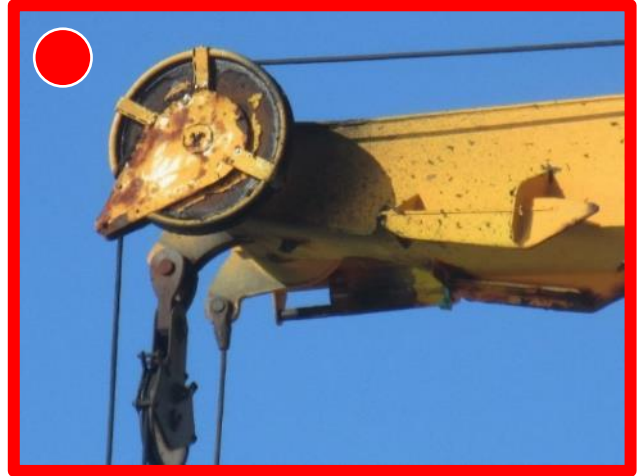
Jib end sheave with excessive corrosion

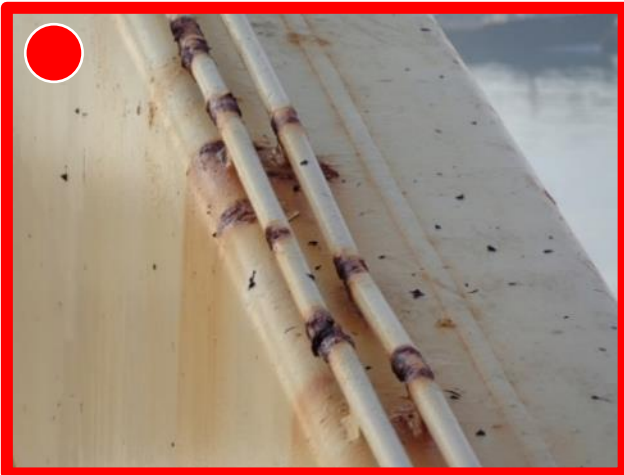
Excessive corroded cable protection piping

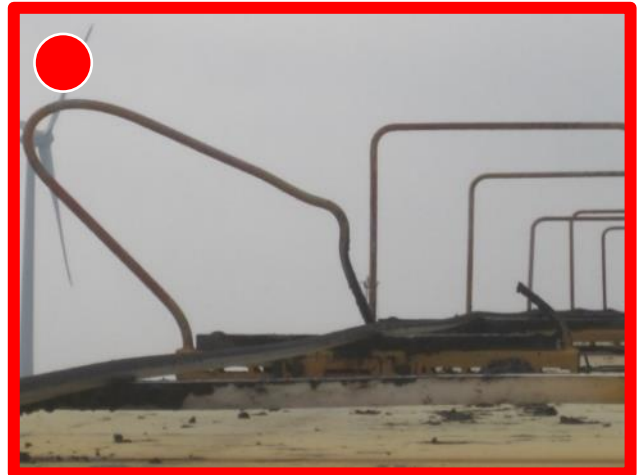
Distorted wire jumper

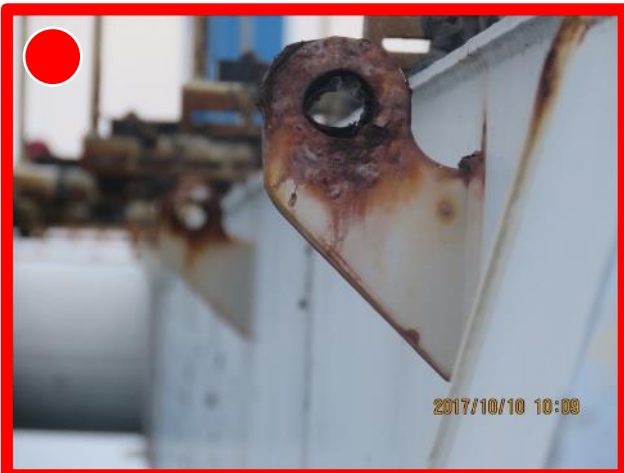
Lifting eyes on jib with excessive corrosion

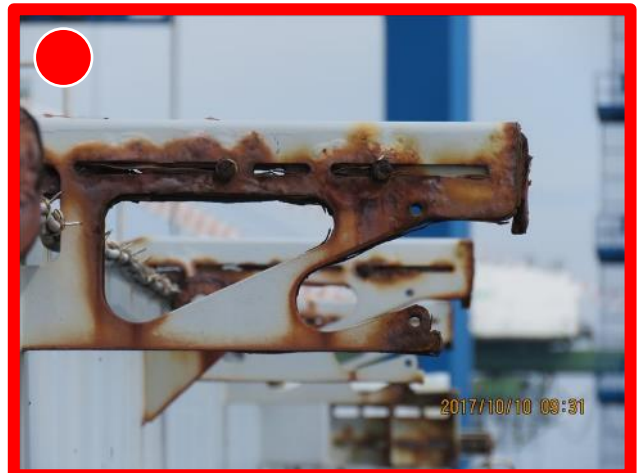
Excessive corroded grating support

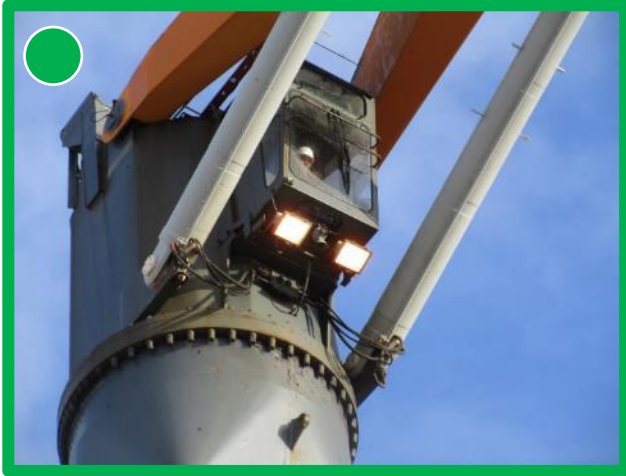
Luffing cylinders sound, no corrosion

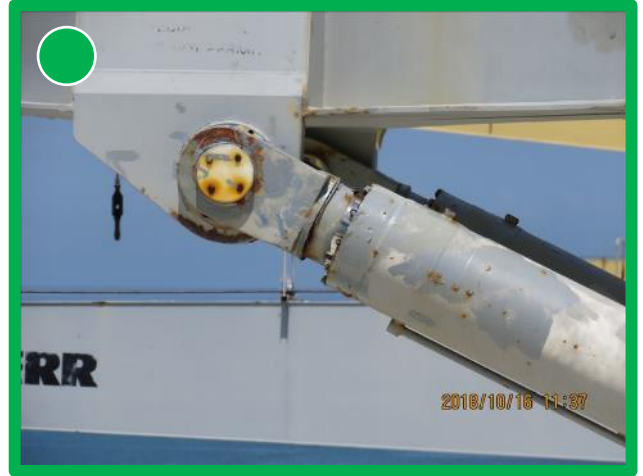
Limited corrosion on jib / luffing cylinder mounting

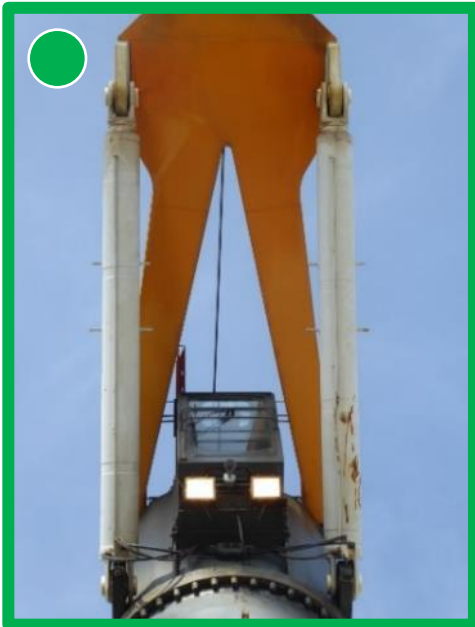
Luffing cylinders with spot corrosion

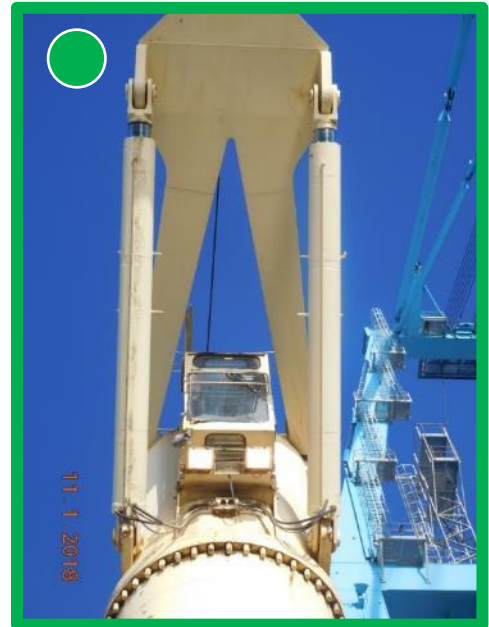
Luffing cylinders sound, no corrosion

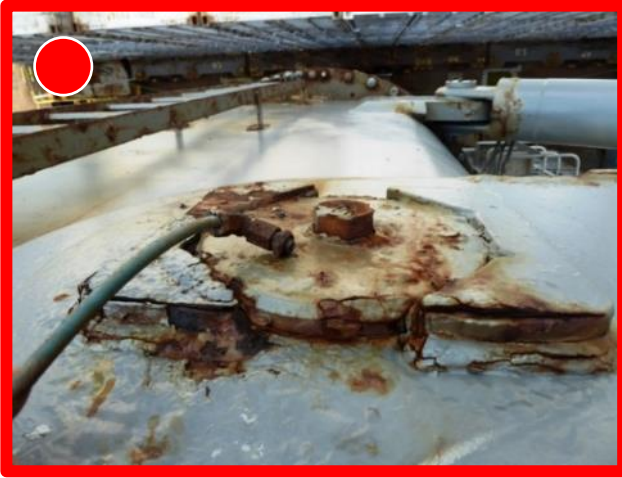
Jib pivot point / hinge pin with excessive corrosion

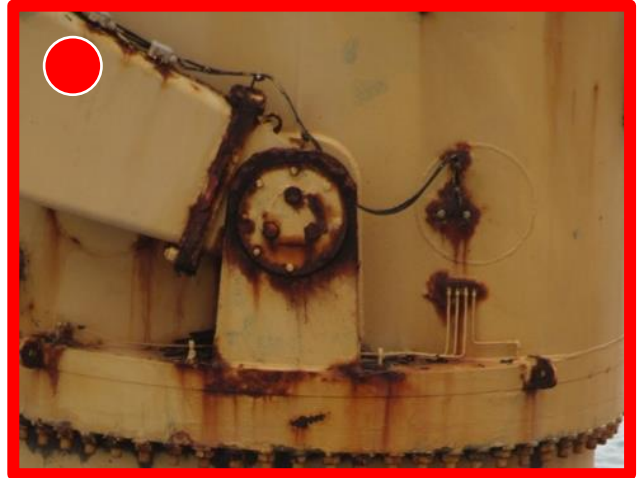
Jib hinge with excessive corrosion (also on slewing ring)

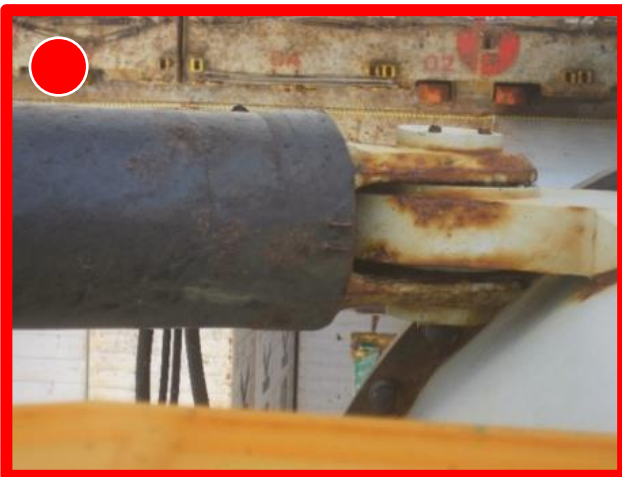
Luffing cylinder mounting with excessive corrosion

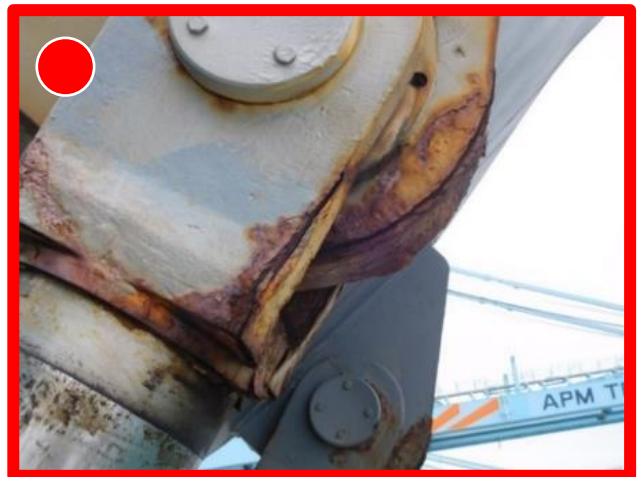
Excessive corrosion on jib mounting point

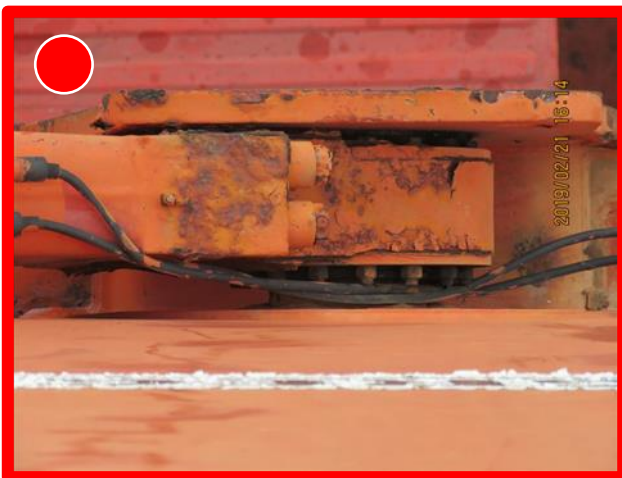
Excessive corrosion on jib mounting

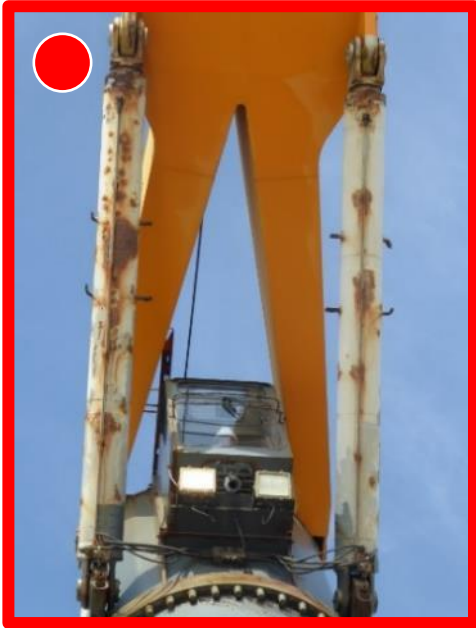
Luffing cylinders with excessive corrosion

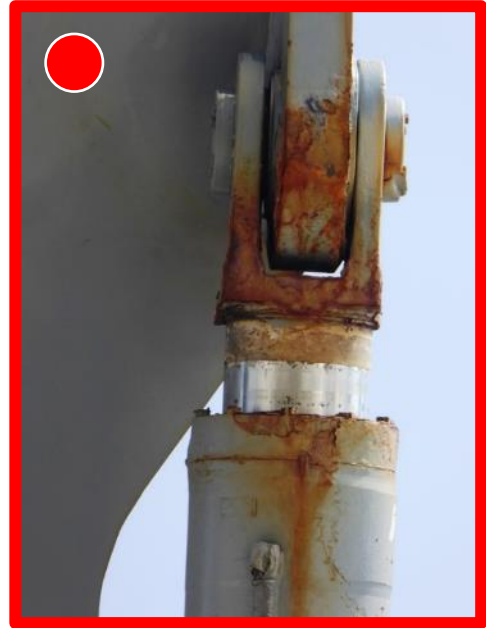
Excessive corrosion on jib mounting

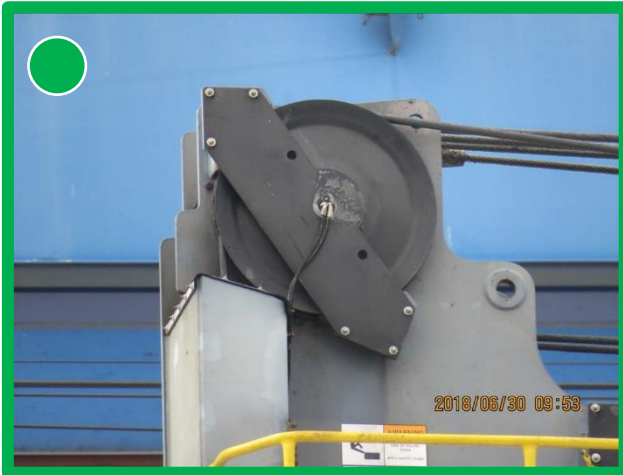
Crane top wire sheave, sound

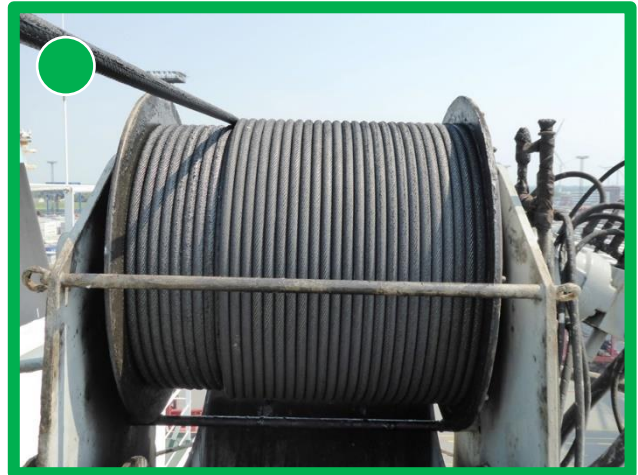
Wire drum with minor, progressing rust

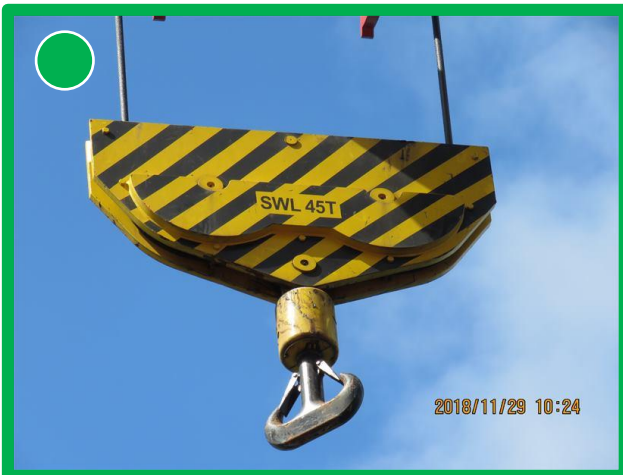
Block in good condition and safety latches operational

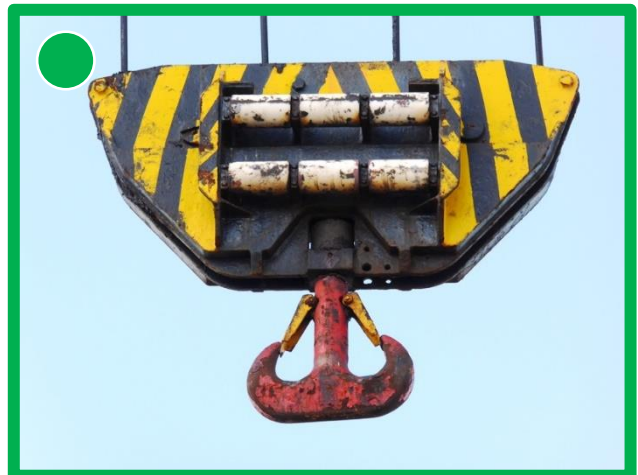
Block fair and safety latches operational

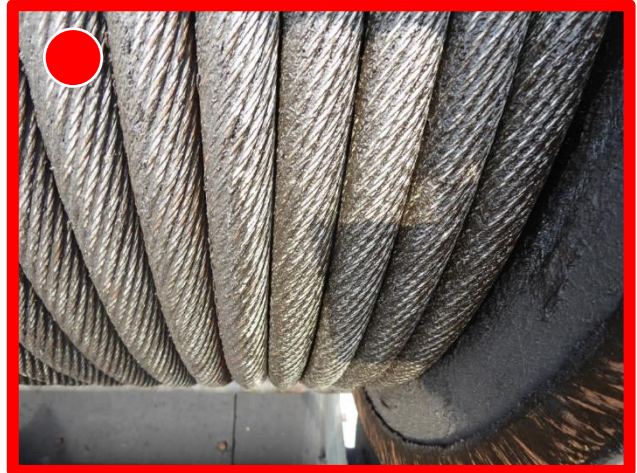
Wire dry, lacking grease

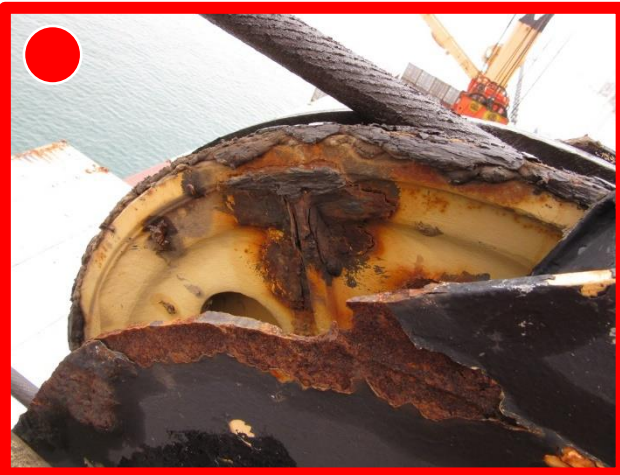
Wire sheave with excessive corrosion

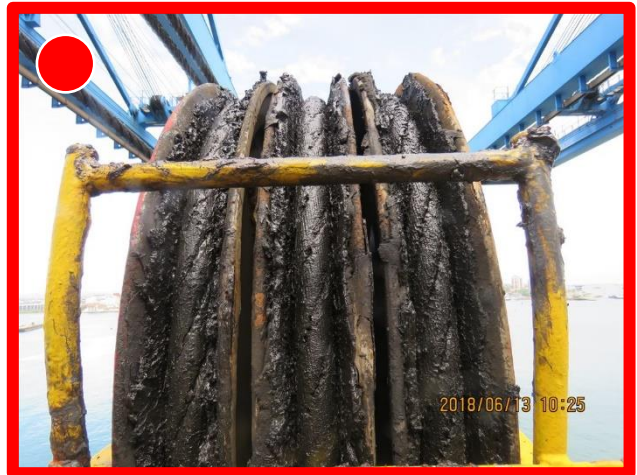
Wire sheave with corroded edges

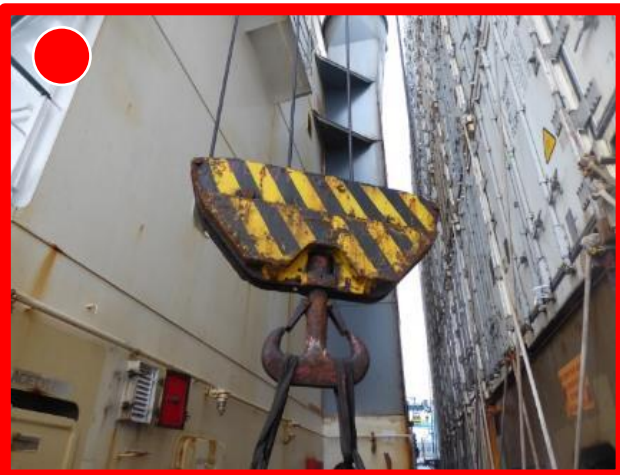
Block with excessive corrosion

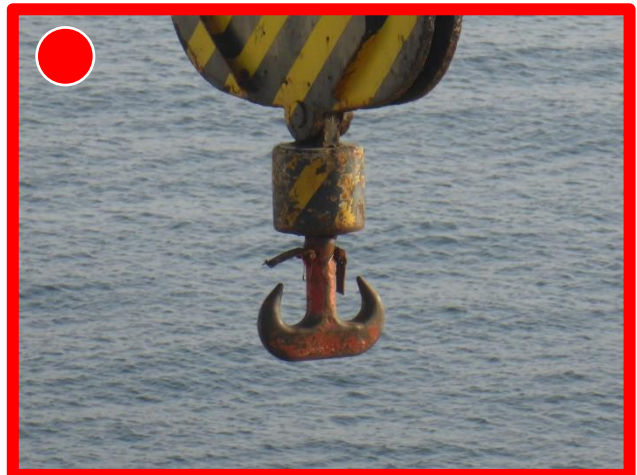
Safety latches inoperable

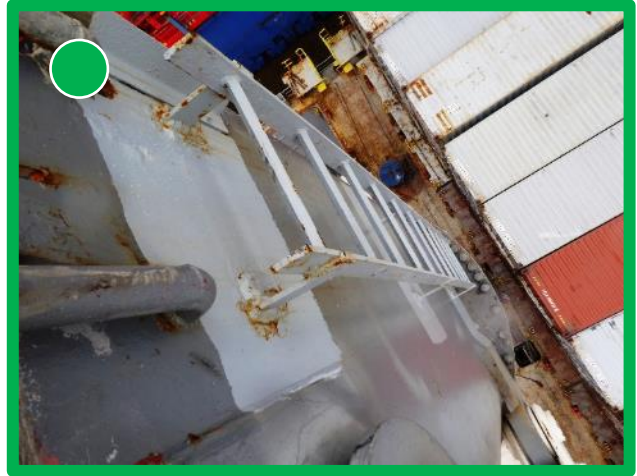
Ladder with some progressing rust

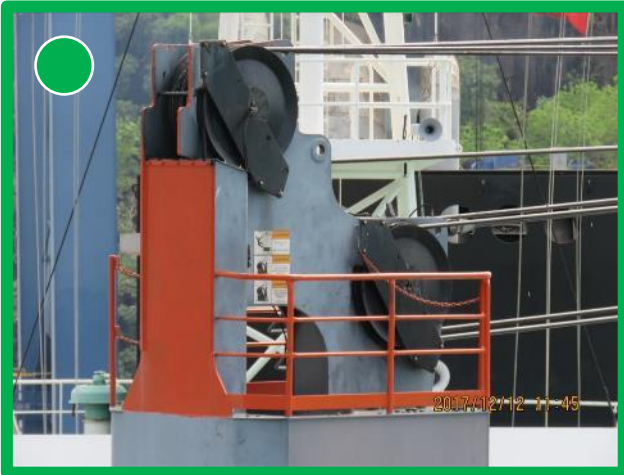
Topside handrailing sound

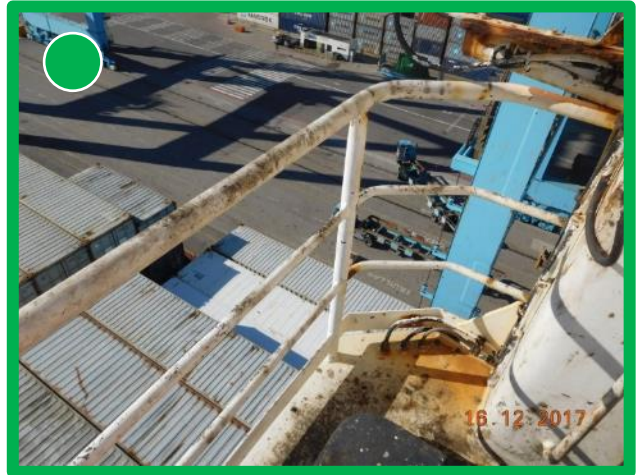
Handrailing with superficial corrosion

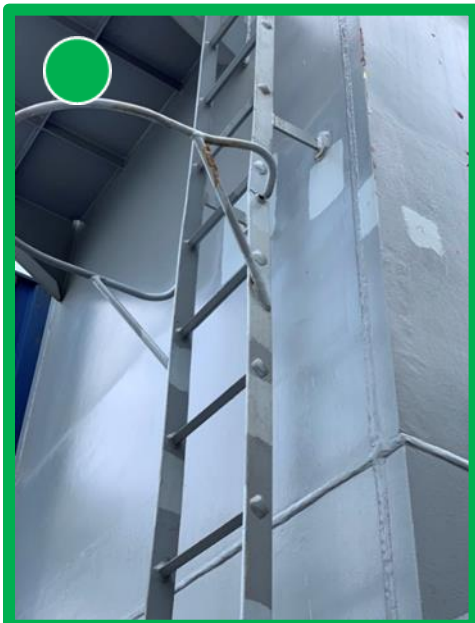
Minorly damaged/deformed ladder safety ring

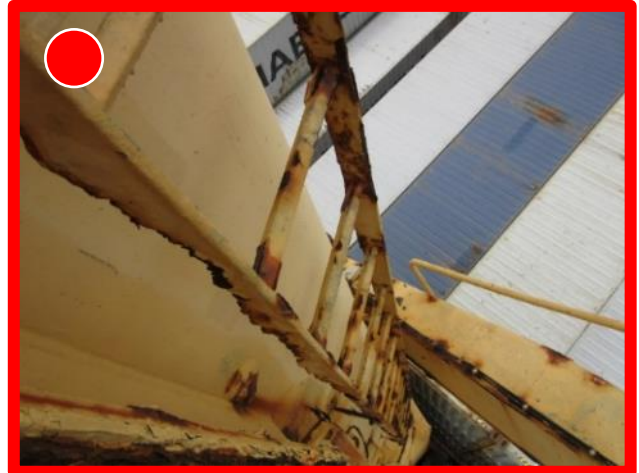
Excessive corrosion / wastage on pedestal ladder

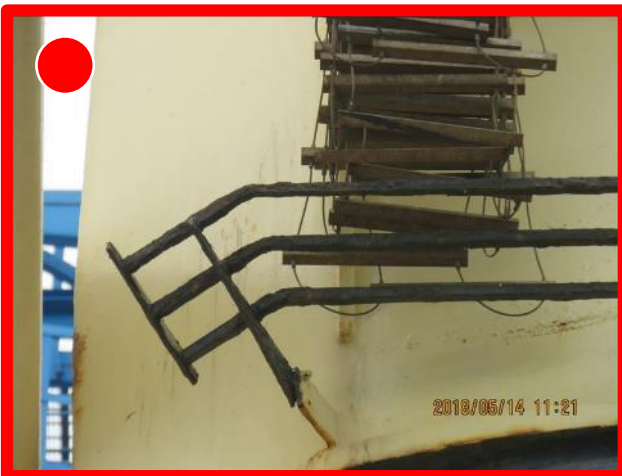
Wastage on emergency escape platform / grid

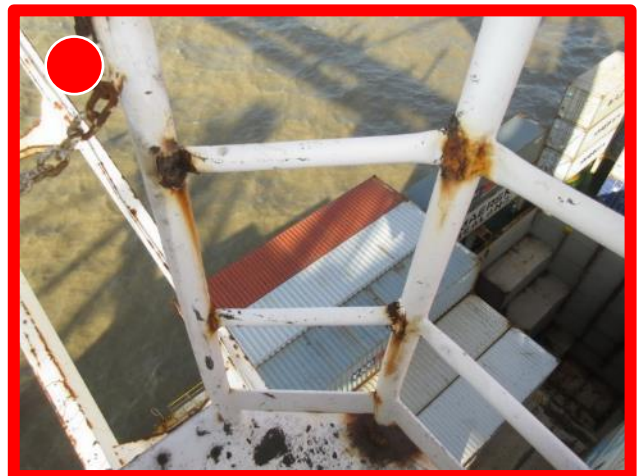
Excessive corrosion on topside handrail

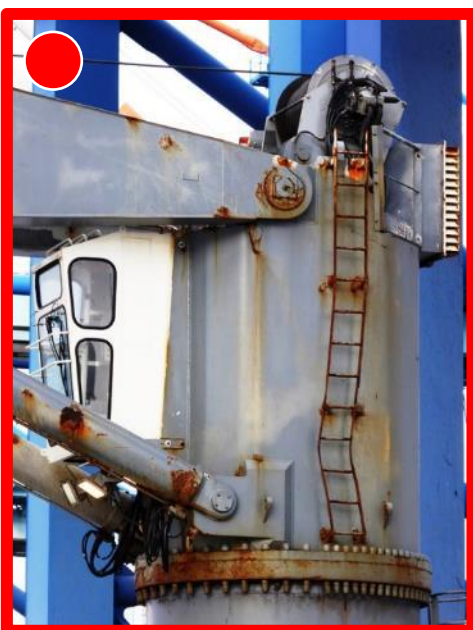
External ladder with excessive corrosion and distorted.

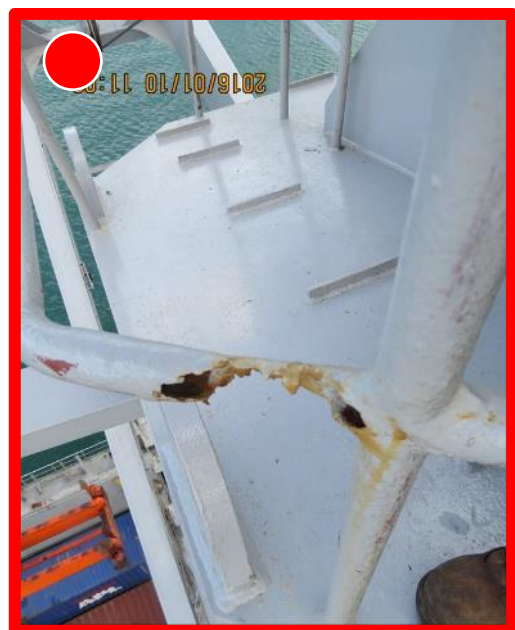
Topside handrailing with wastage

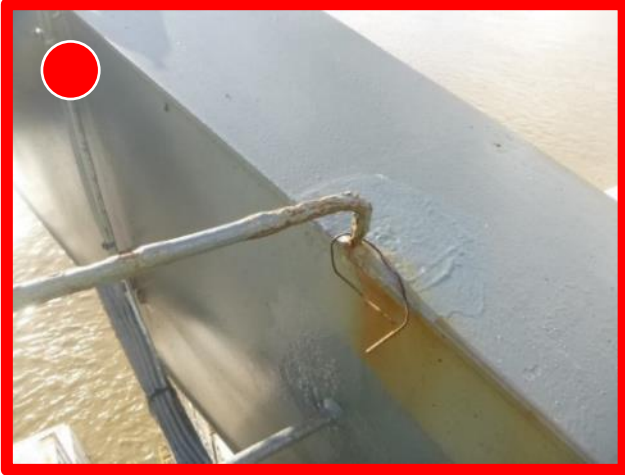
Excessive corrosion on handrail at the base of the jib

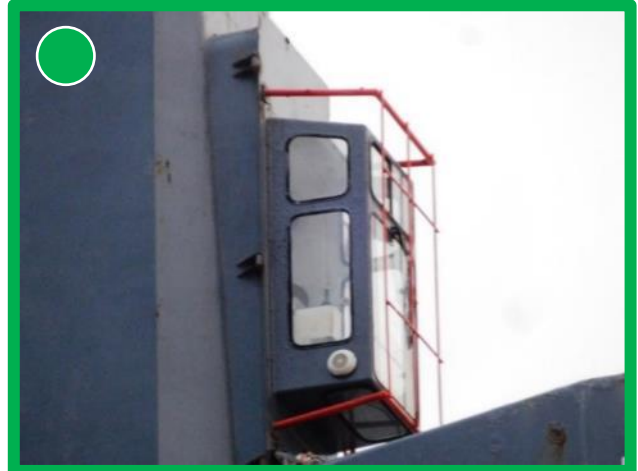
Operator's cabin with superficial corrosion

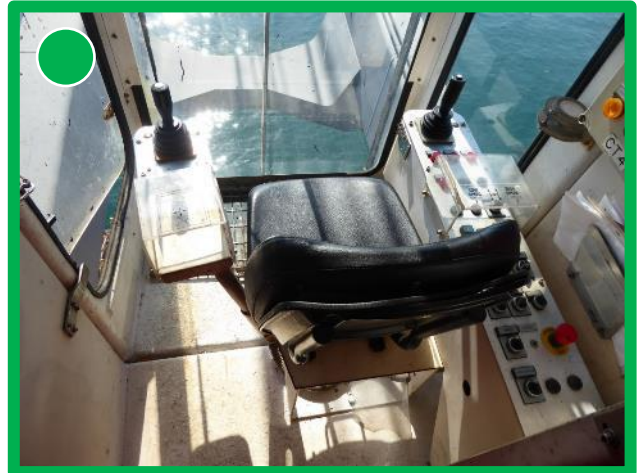
Interior, sound

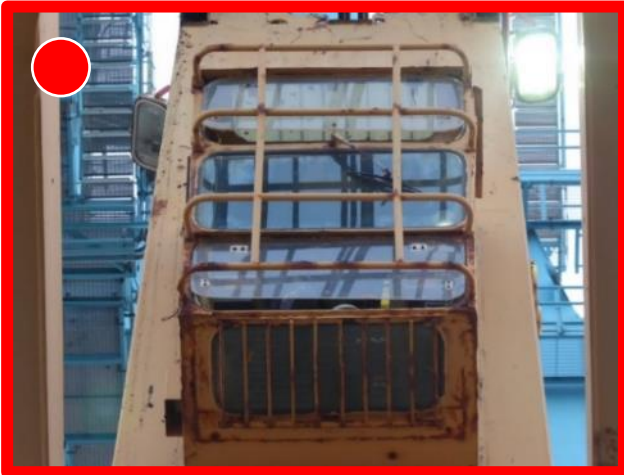
Operator's cabin exterior with excessive corrosion

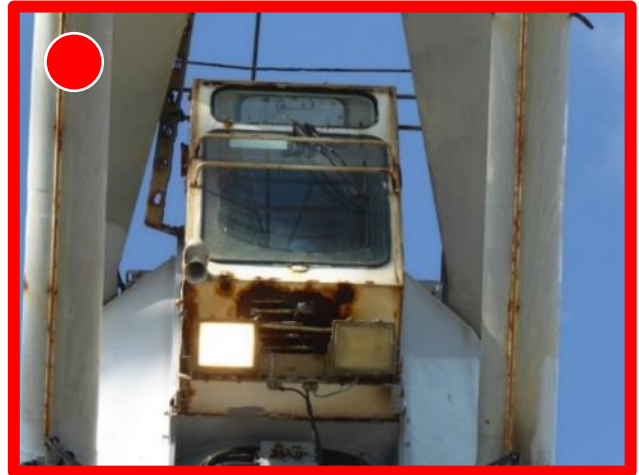
Operator's cabin exterior with excessive corrosion (and one inoperative flood light)

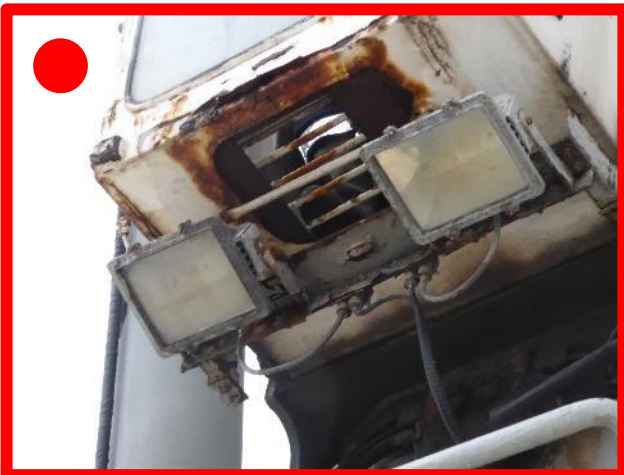
Cabin structure excessively corroded / local wastage

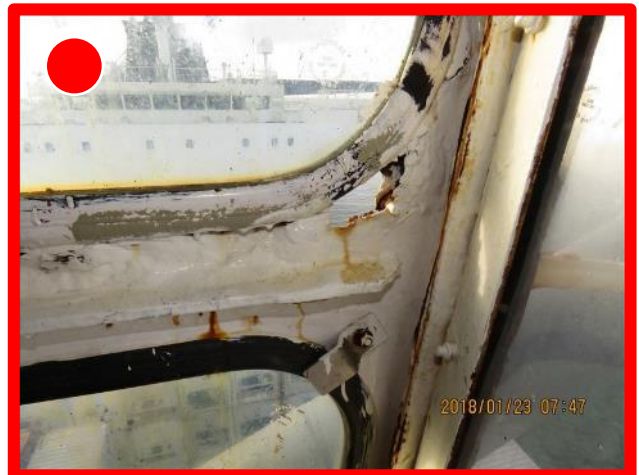
Inside view: cabin structure wasted

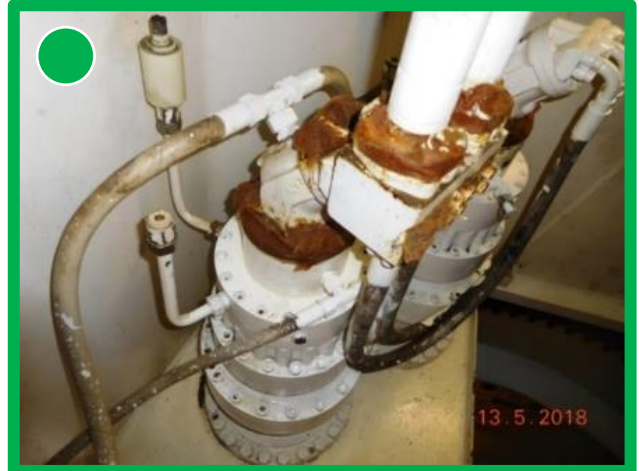
Anti-corrosion tape on slewing motor couplings

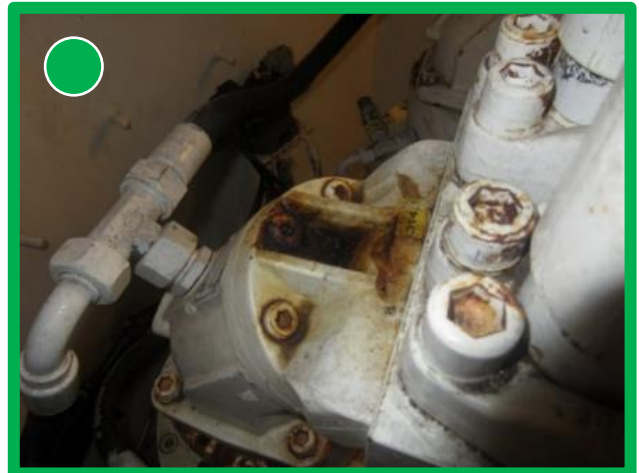
Progressive corrosion on valve block

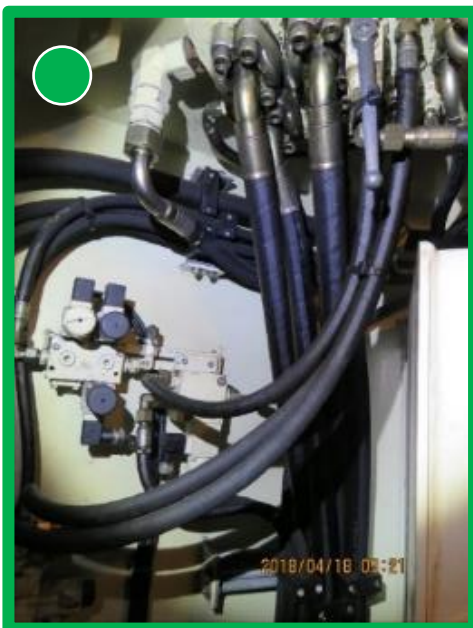
Hoses sound, shiny appearance not related to leakage because there is no dripping of oil

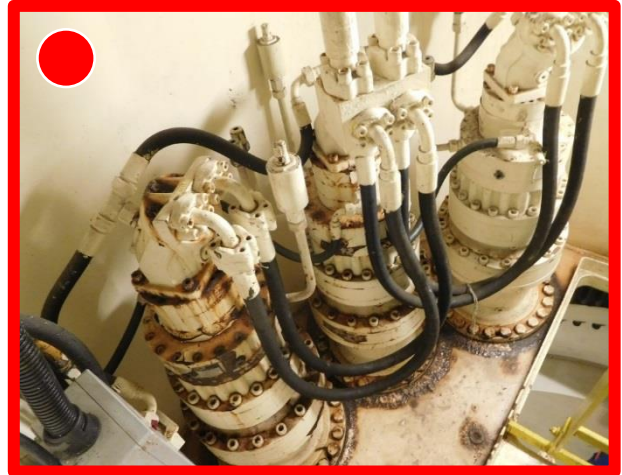
Slewing motors with excessive corrosion

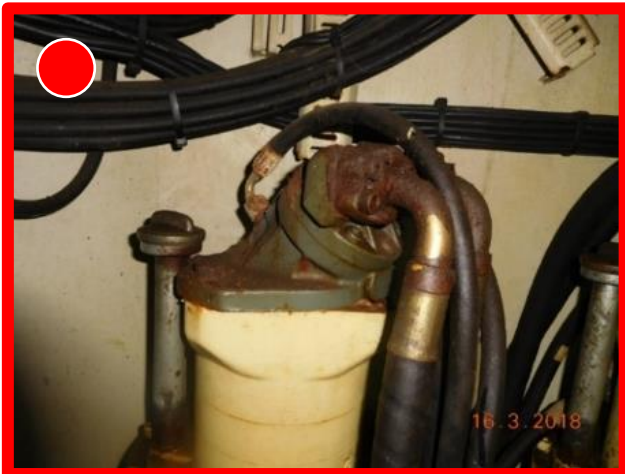
Excessive corrosion on valve block

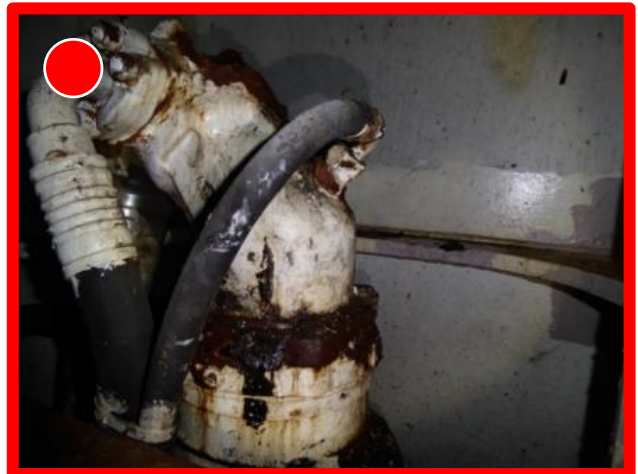
Excessive corrosion on valve block

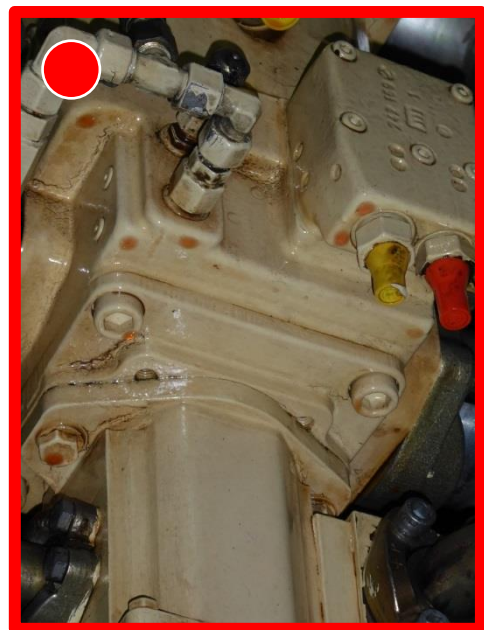
Oil drips adhering on pump

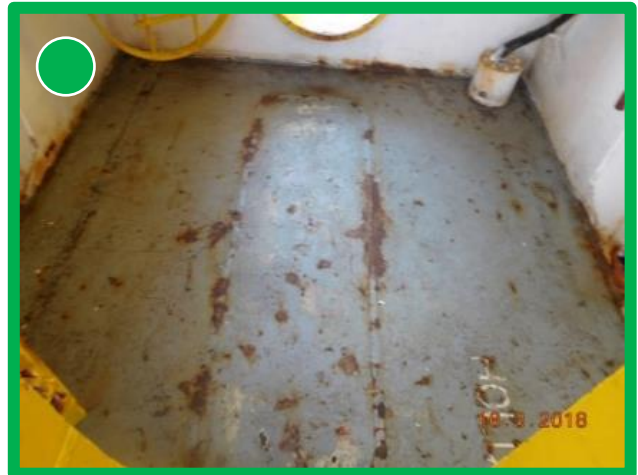
Progressing corrosion on entrance deck

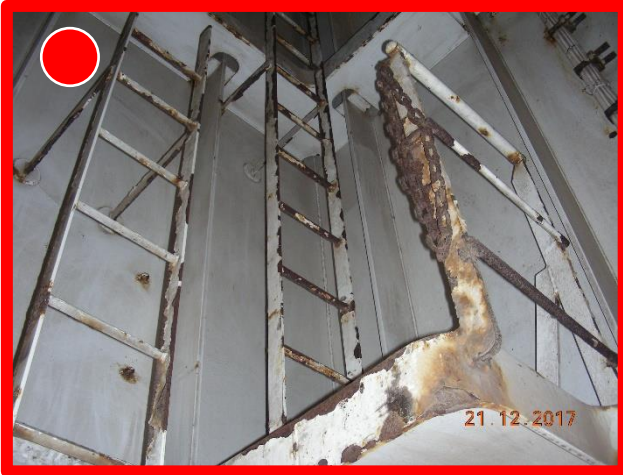
Interior and ladders with excessive corrosion

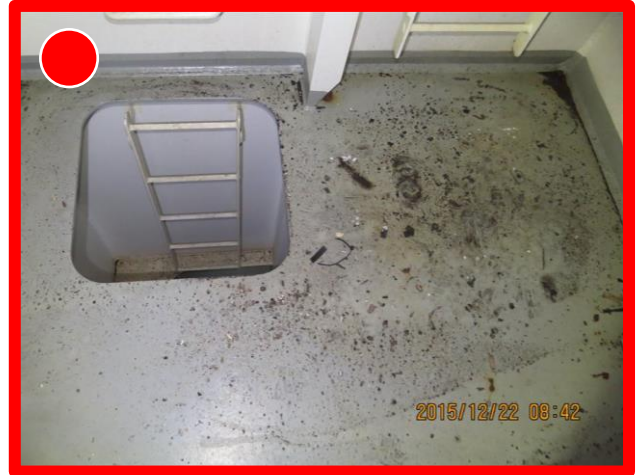
Interior platform, dirty
